Manhole Inspection Summary

Manhole # S04EE2003MH

Insp Date: **9/21/06 1:35 PM**

Location Address: **7013 WALLIS AVE**

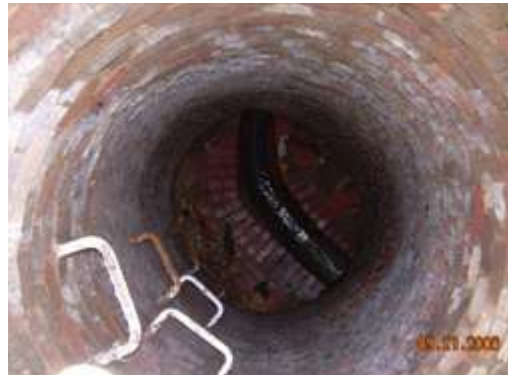
Top View

Bench ☒ Exists Material: **Brick** ☐ Parged ☒ **Debris** (not Condition related)

Steps Count: **7** Missing: **0** ☒ **Corroded**

Surcharge ☒ **Evidence Of Surcharge** Depth: **2** (ft.) ☐ Active Surcharge Present

Corroded steps. Evidence of surcharge.
Bench debris.

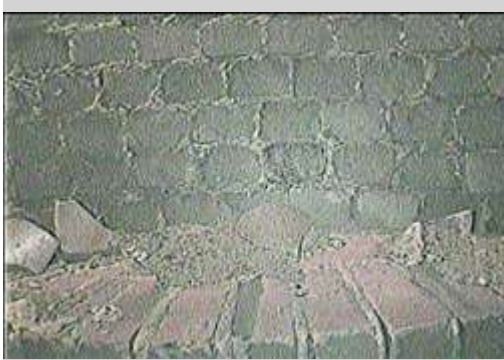
Defect

Condition: ☐ Sound ☐ Cracked ☐ Root Intrusion ☐ Loose Brick ☒ **Deteriorated**

Infiltration: ☐ None ☐ Joint ☐ Cracks ☒ **Mortar** ☐ Roots ☒ **Wall**

Condition: ☐ Sound ☐ Cracked ☐ Root Intrusion ☒ **Deteriorated** ☐ Leaks ☐ Debris

Barrel deterioration and infiltration. Bench deterioration.

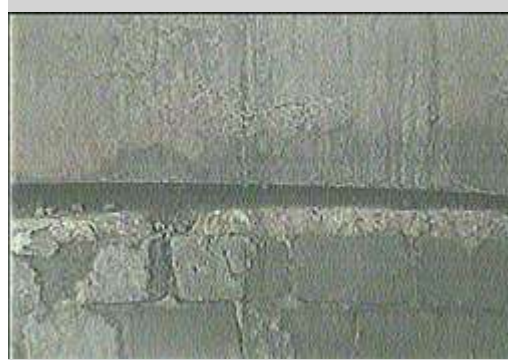
Defect

Condition: ☐ Sound ☐ Cracked ☐ Root Intrusion ☐ Loose Brick ☒ **Deteriorated**

Infiltration: ☐ None ☒ **Joint** ☐ Cracks ☐ Mortar ☐ Roots ☐ Wall

Adjustment deterioration and infiltration.

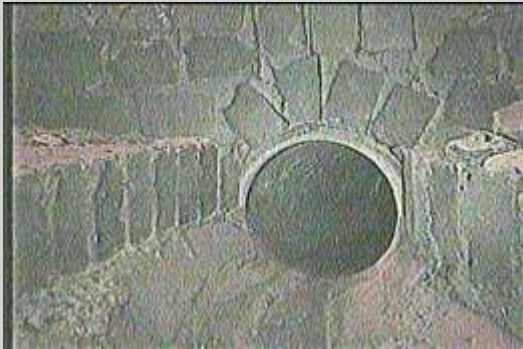
8 in. Circular Gravity Sewer Pipe Out @ 12 O'Clock

Infiltration: **Evidence** Pipe Seal Cond: **Unknown**

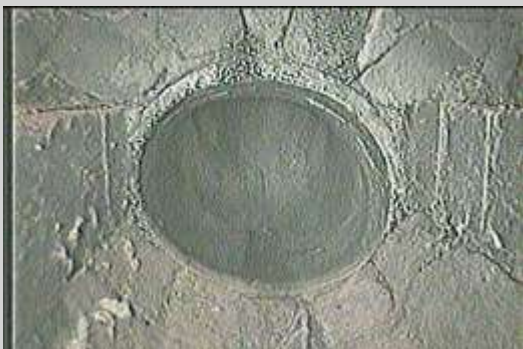
8 in. Circular Gravity Sewer Pipe In @ 4 O'Clock

Condition: ☐ Sound ☐ Cracked ☐ Root Intrusion ☒ **Deteriorated** ☐ Leaks ☐ Debris

Channel deterioration.

Infiltration: **Evidence** Pipe Seal Cond: **Unknown**
